# Manhole Inspection Summary

Manhole # S37EE\_047MH

Insp Date: **3/22/07 11:11 AM**

**Location** Address: **317 BIDDLE ST**

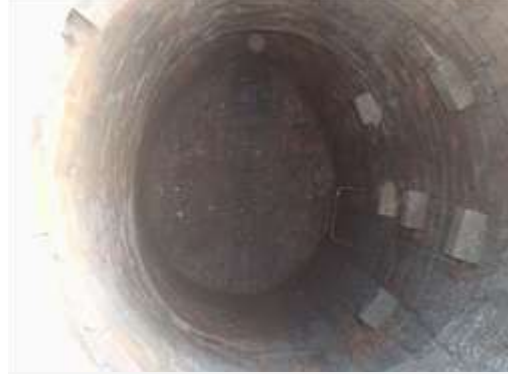
Top View

Comments **This MH should have at least 5 steps. It only has one.**

Channel debris. Missing steps.

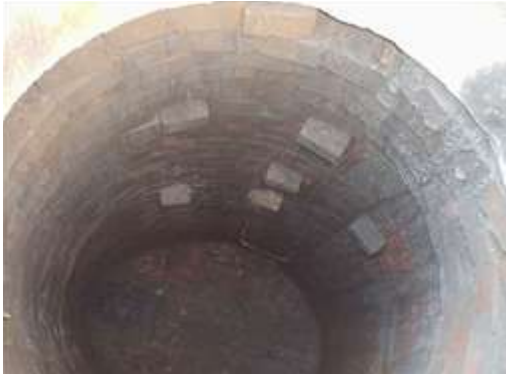
Defect

Frame leaks. Adjustment deterioration, loose brick and infiltration. Corbel and Barrel infiltration.

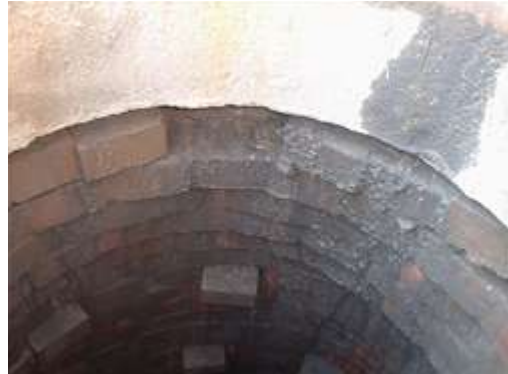
Defect

Frame leaks. Adjustment deterioration, loose brick and infiltration. Corbel and Barrel infiltration.

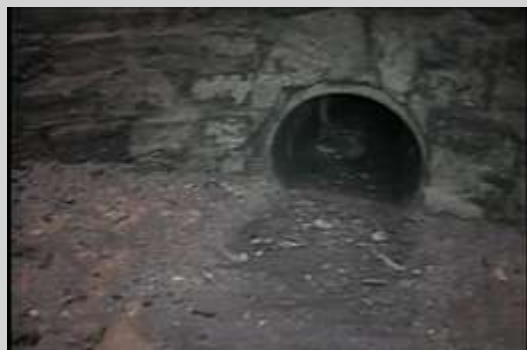
Pipe Out @ 12 O'Clock

Deposits: ☐ None ☒ **Mud** ☐ Sludge ☒ **Debris** ☐ Grease

Infiltration: **Evidence**

Pipe Seal Cond: **Cracked**
